# 5th Australian Aeronautical Conference

## THE DAMAGE AND FAILURE OF GRP LAMINATES BY UNDERWATER EXPLOSION SHOCK LOADING

A.P. Mouritz and D.S. Saunders

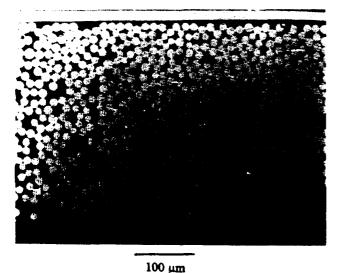
Figure 6. A scanning electron micrograph showing a crack in the resin weaving between the glass fibres.

The examination of the microstructure of the GRP after shock testing revealed that the glass fibres either stopped or deflected the cracks within the polymer matrix (Figures 5 and 6), and thereby improved the underwater shock resistance of the laminate. Furthermore, it is believed that the fibres take a large proportion of the tensile loads resulting from the bending of the laminates under shock loading. These experiments have clearly shown that the glass fibres provide most of the shock resistance, and this can be attributed to the significantly lower tensile failure strength of the polymer.

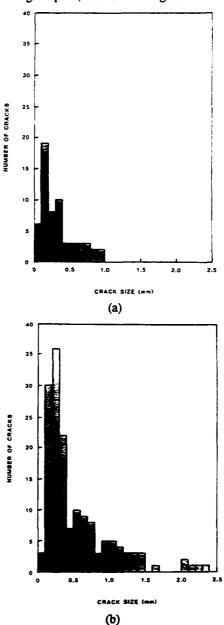
raising the maximum pressure from 31 MPa to 57 MPa increased the density of resin cracks observed on the polished surfaces from 0.8 x 10<sup>6</sup> m<sup>-2</sup> to 2.2 x 10<sup>6</sup> m<sup>-2</sup>, respectively. Figures 7a and 7b present histograms of crack size against number of cracks for the GRP after being tested at maximum shock pressures of 31 MPa and 57 MPa, respectively. For a pressure of 31 MPa, the average crack size was measured to be 0.380 mm with a maximum size of 1.0 mm. Raising the pressure to 57 MPa increased the average crack size to 0.516 mm with a maximum size of 2.4 mm. In the samples tested above 11 MPa many of the glass fibres were broken, and there was extensive delamination between the glass plies, as shown in Figure 8.

Figure 7. Histograms of crack length plotted against number of cracks for the GRP after being tested at a maximum shock pressure of (a) 31 MPa and (b) 57 MPa.
